PRE-DEMOLITION ASBESTOS SURVEY

**12 REED PARK
ROCHESTER, NEW YORK**

**CITY OF ROCHESTER
30 CHURCH STREET
ROOM 005A
ROCHESTER, NEW YORK 14614**

February 25, 2016

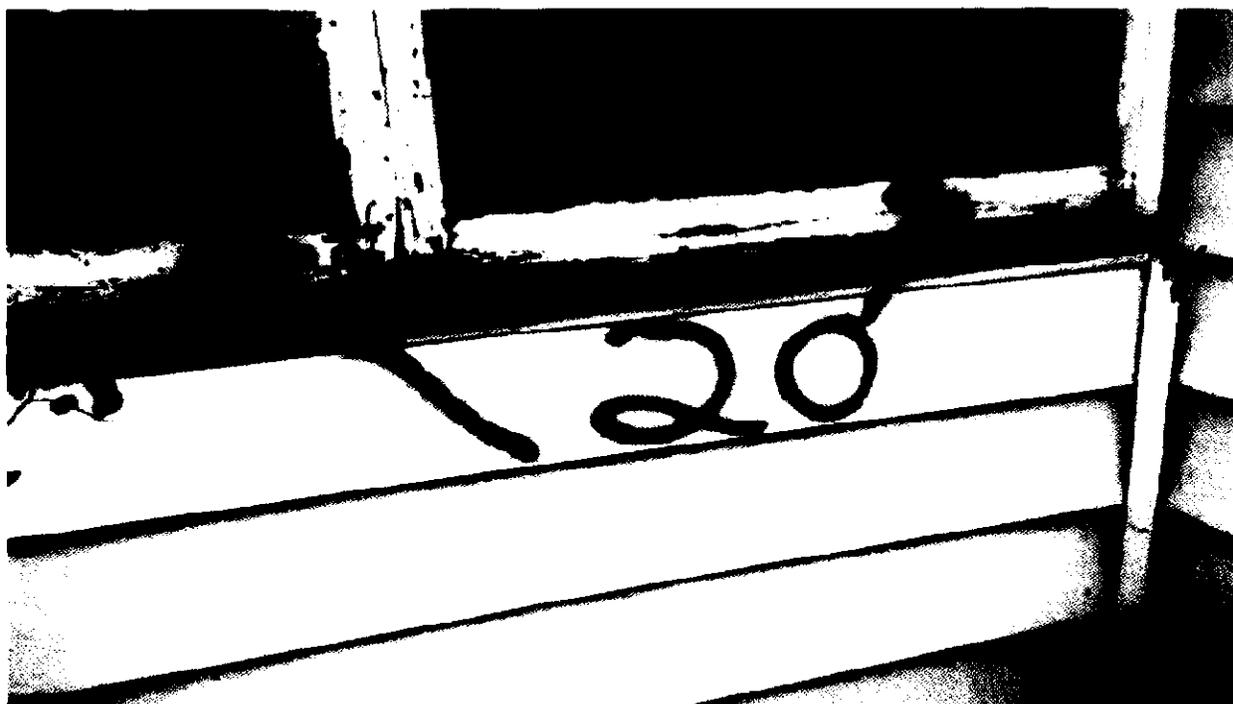
Figure 3: Bedroom 1- Sample No. 20: White Window Glaze

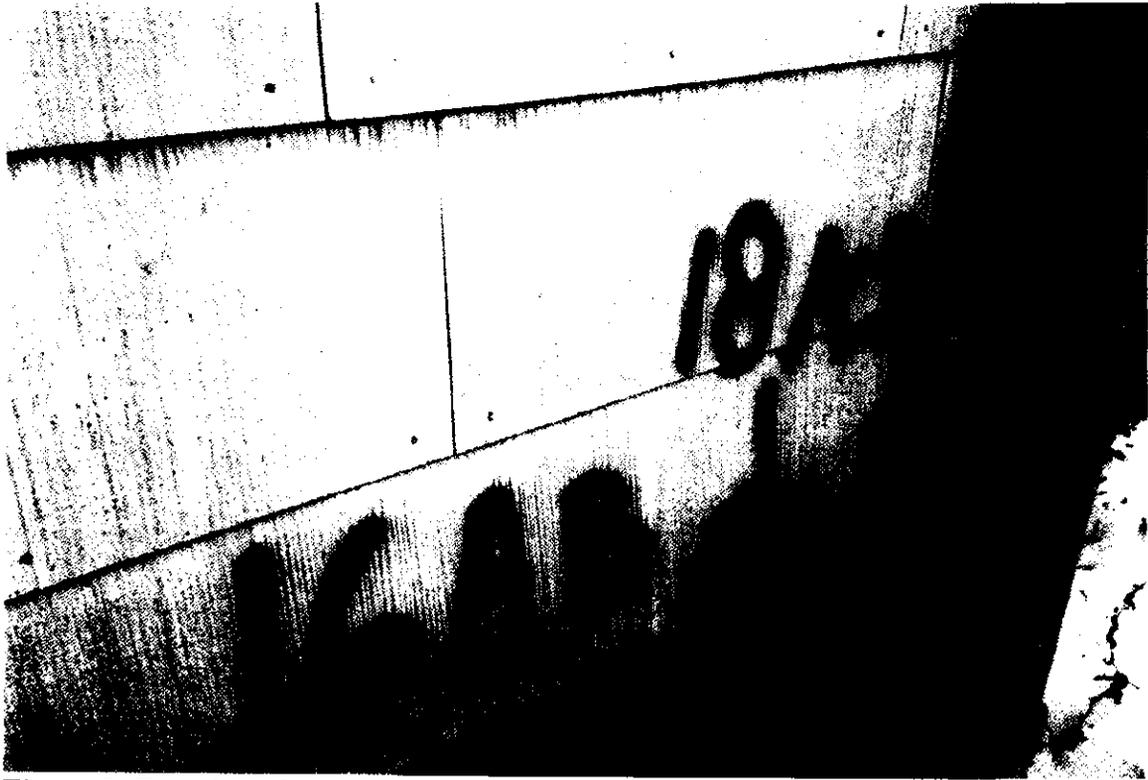
Figure 5: Exterior - Sample No. 16A & 18A: Gray Cementitious Siding

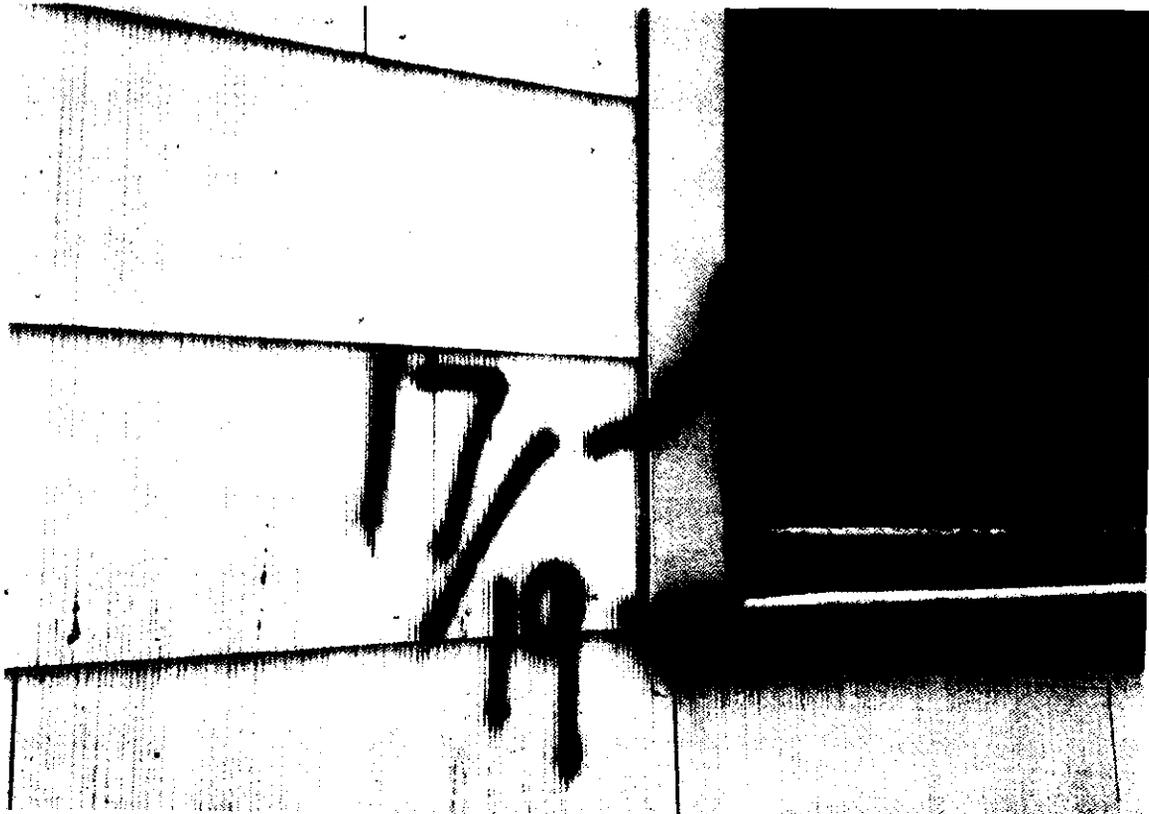
Figure 6: Exterior - Sample No. 17 & 19: White/Gray Caulk
