Dept. of Neighborhood & Business Development
Rochester, New York

Pre-Demolition
Asbestos Inspection

5 Utica Place
Rochester, New York

Barton & Loguidice, P.C.
Engineers • Environmental Scientists • Planners • Landscape Architects
11 Centre Park, Suite 203
Rochester, New York 14614

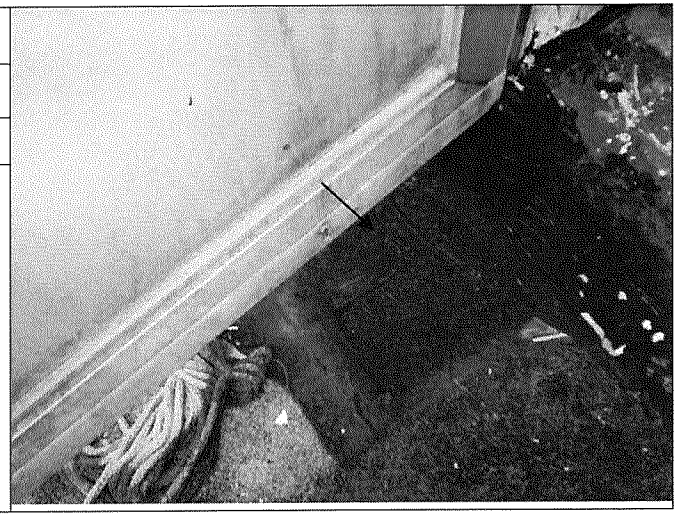
Photo No. 2	
Location: 207

Sample No. RM03A	
Description: BLACK ROOF CEMENT 2.7% CH

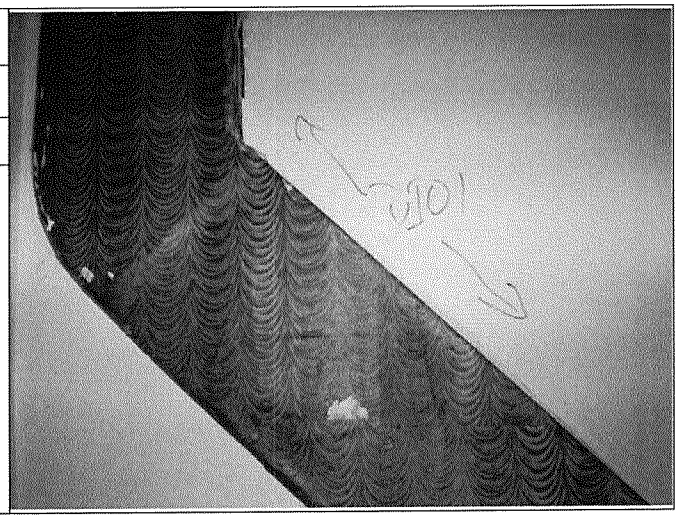
Photo No. 3	
Location: 103A

Sample No. NOT SAMPLED	
Description: DUCT INSULATION PRESUMED ACM

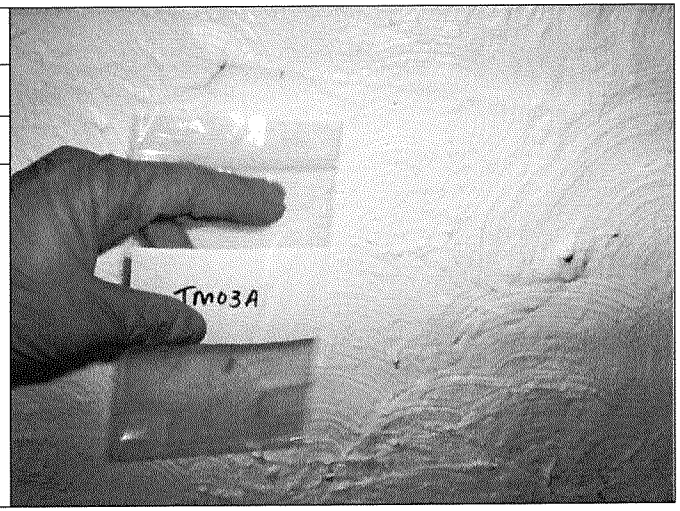
Photo No.	
7

Location: 205	
Sample No.: TM03A	
Description: CEILING STUCCO NON-ACM

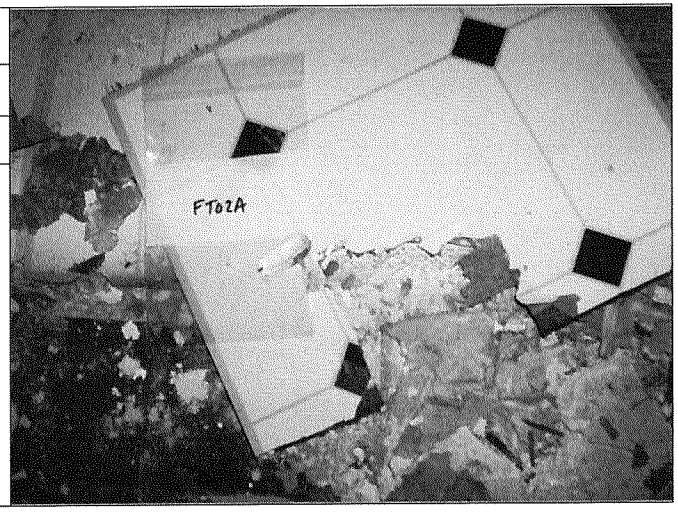
Photo No.	
12

Location **105**	
Sample No. **FT02A**	
Description **12"X12" WHITE SQUARE W/ BLACK DIAMOND FLOOR TILE NON-ACM**

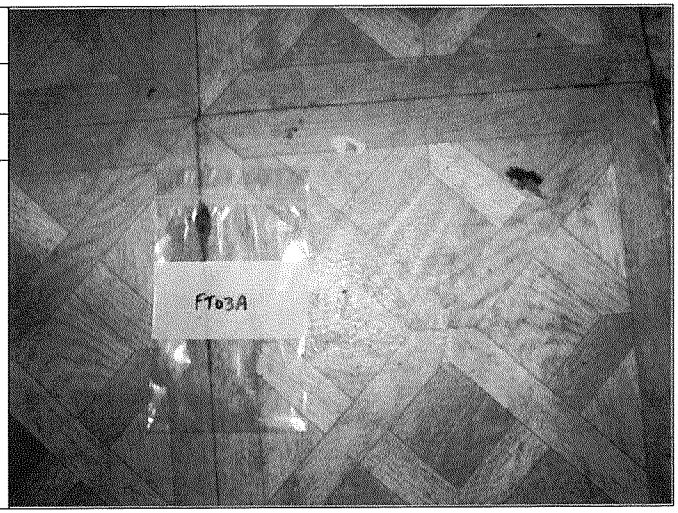
Photo No. 13	
Location 205

Sample No. FT03A	
Description 12"X12" PARQUET PATTERN SHEETING NON-ACM

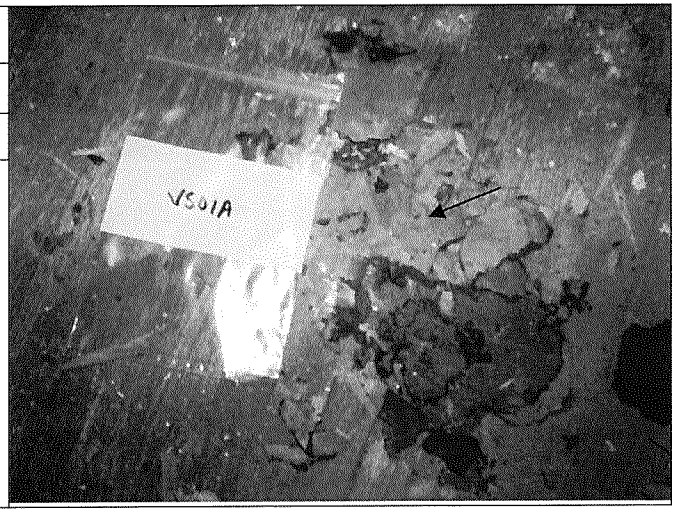
Photo No. 14	
Location 102

Sample No. VS01A	
Description GREEN DESIGN SHEETING NON-ACM

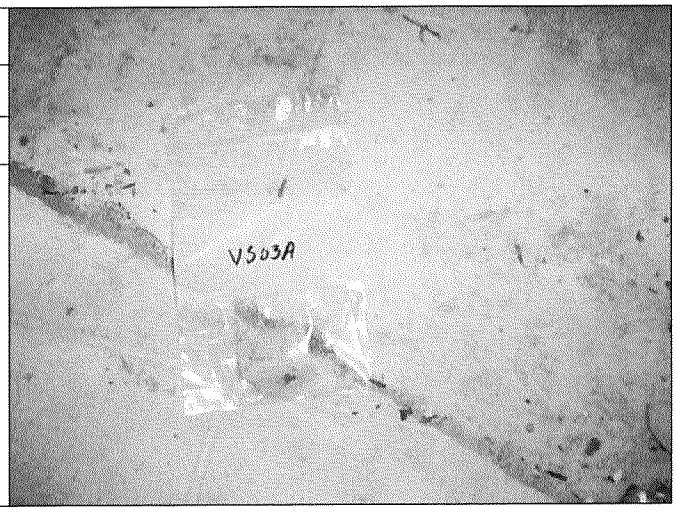
Photo No. 16	
Location 200

Sample No. VS03A	
Description WHITE LARGE SQUARE SHEETING NON-ACM

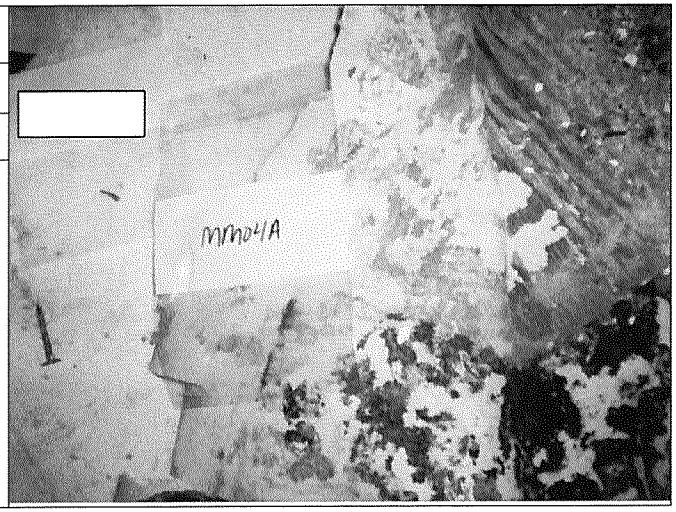
Photo No. 22	
Location: 200

Sample No.: MM04A	
Description: TAN FLOOR MASTIC NON-ACM

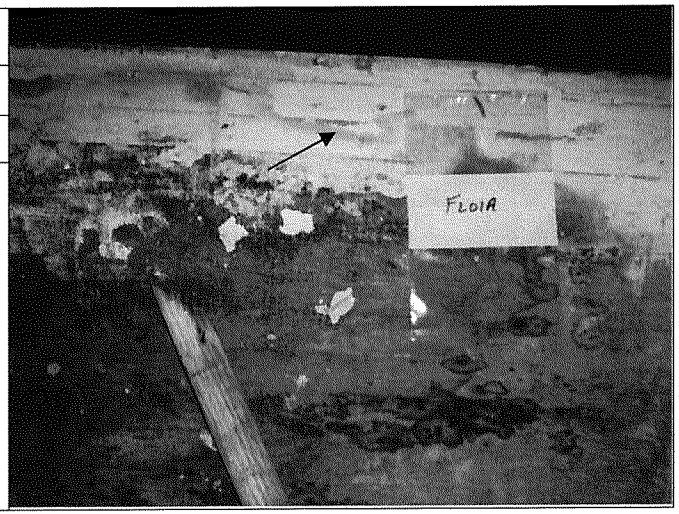
Photo No.	
25

Location **101**	
Sample No. **FL01A**	
Description **TAN FLOOR LEVELER NON-ACM**

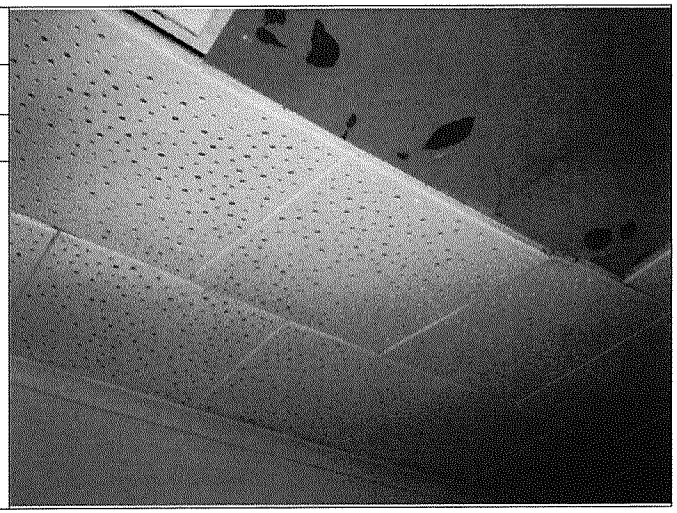
Photo No.	
26

Location **102**	
Sample No. **CT01A**	
Description **1'X2' LARGE HOLE CEILING TILE NON-ACM**

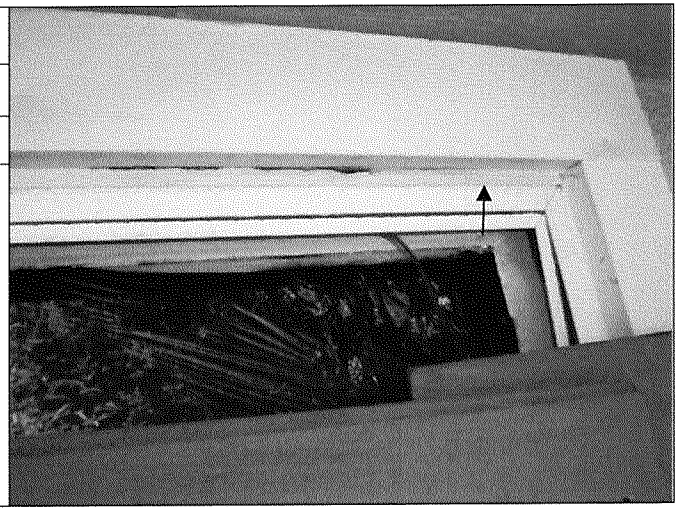
Photo No.	
27

Location **EXTERIOR**	
Sample No. **WC01A**	
Description **WHITE WINDOW CAULK NON-ACM**

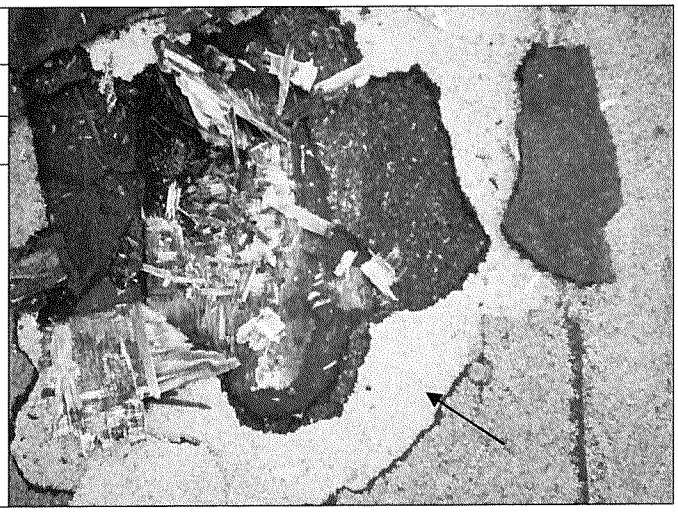
Photo No.	Location	Sample No.	Description
31	**207**	**RM04A**	**GRAY ROLLED ROOFING NON-ACM**

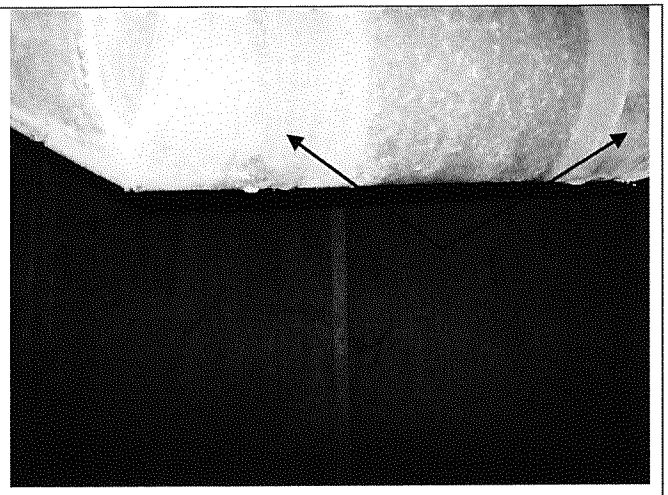
Photo No. 3	
Location: 002

Sample No. NOT SAMPLED	
Description: DUCT INSULATION PRESUMED ACM

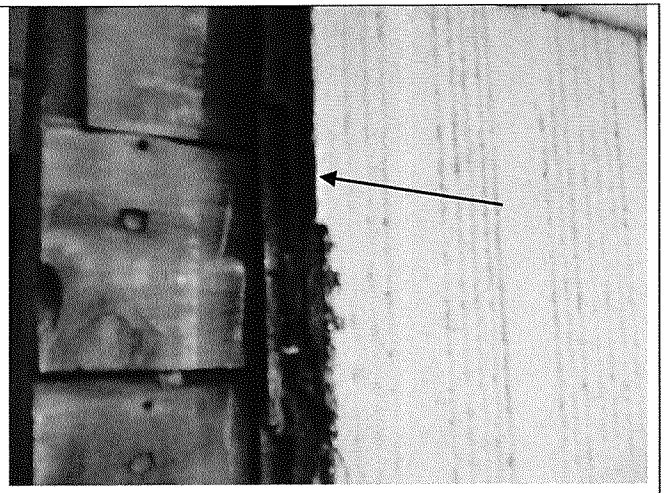
Photo No. 4	
Location: EXTERIOR

Sample No. EC01A	
Description: SIDING CAULK 6.4% CH

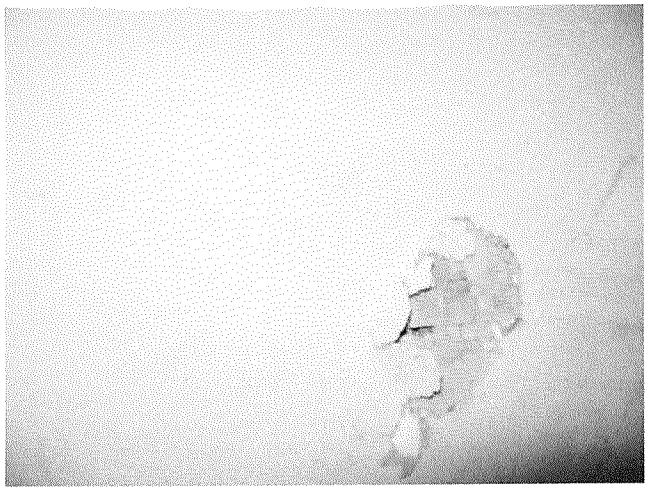
Photo No.	
5

Location **101**	
Sample No. **TM01A**	
Description **TYPICAL PLASTER NON-ACM**

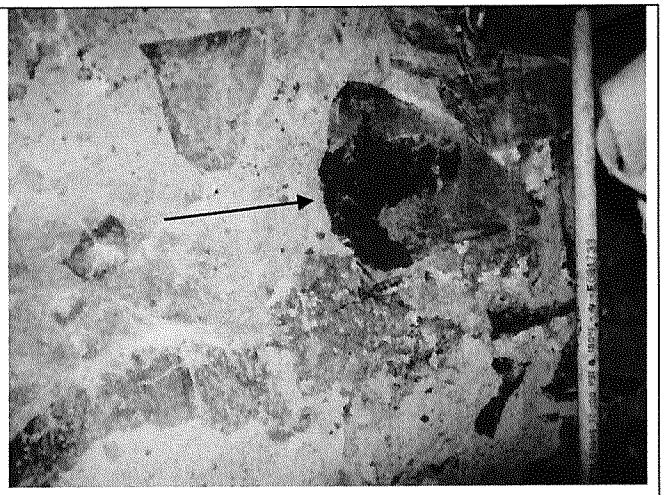
Photo No.	
6

Location **002**	
Sample No. **TM02A**	
Description **BLACK SEALANT NON-ACM**

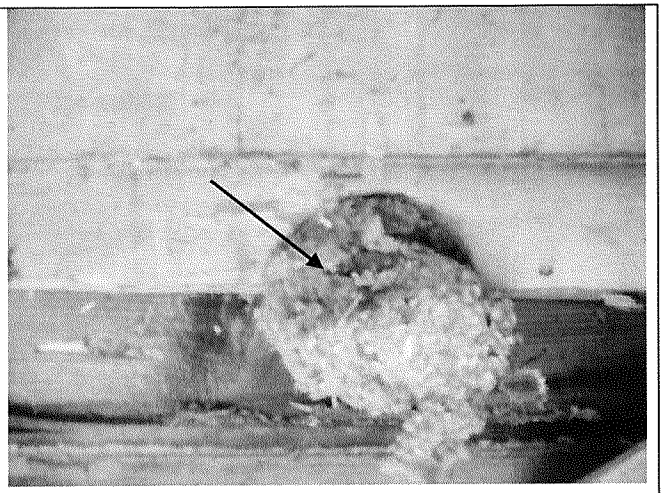
Photo No.	
8

Location **EXTERIOR**	
Sample No. **SM01A**	
Description **BLOWN-IN INSULATION NON-ACM**

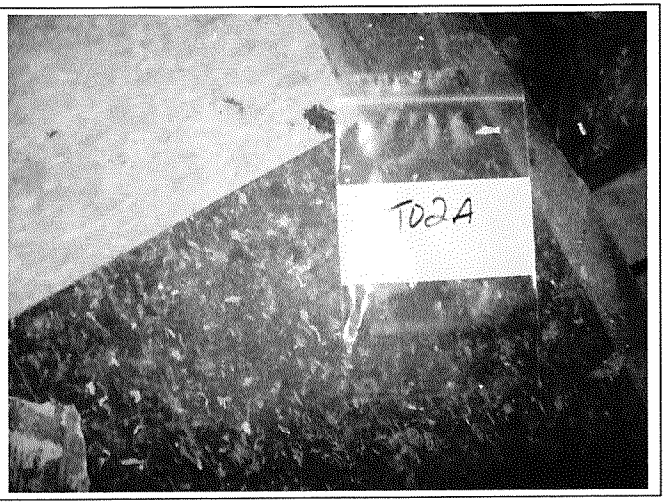
Photo No. 11	
Location: 100

Sample No.: FT02A	
Description: 12"X12" BLACK MOTTLED FLOOR TILE NON-ACM

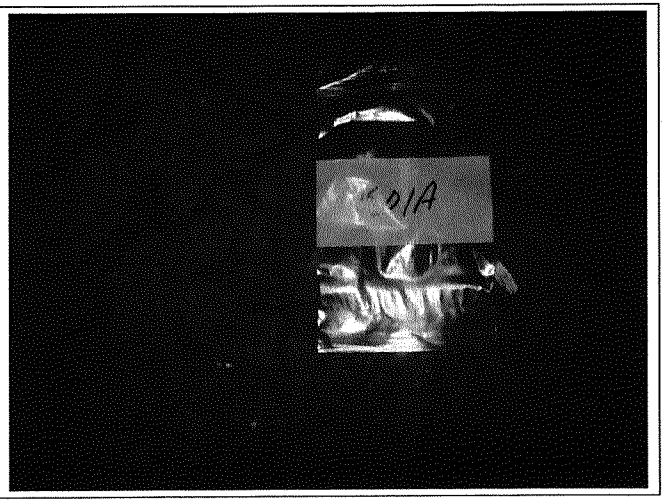
Photo No. 12	
Location: 102

Sample No.: VS01A	
Description: BEIGE & BROWN FLORAL SHEETING NON-ACM

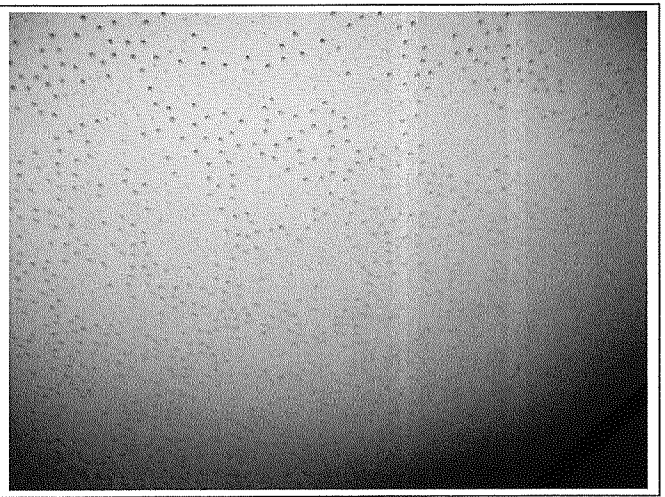
Photo No. 16	
Location: 100

Sample No.: CP01A	
Description: 2'X4' RANDOM HOLE CEILING PANEL NON-ACM

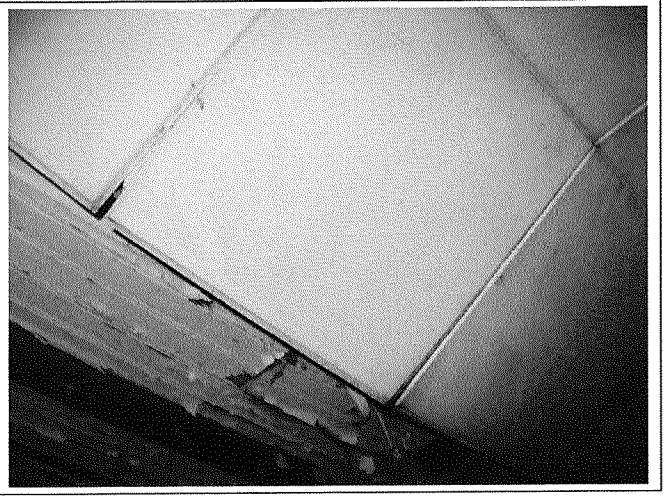
Photo No. 19	
Location: 104

Sample No.: CT01A	
Description: 1'X1' SMOOTH CEILING TILE NON-ACM

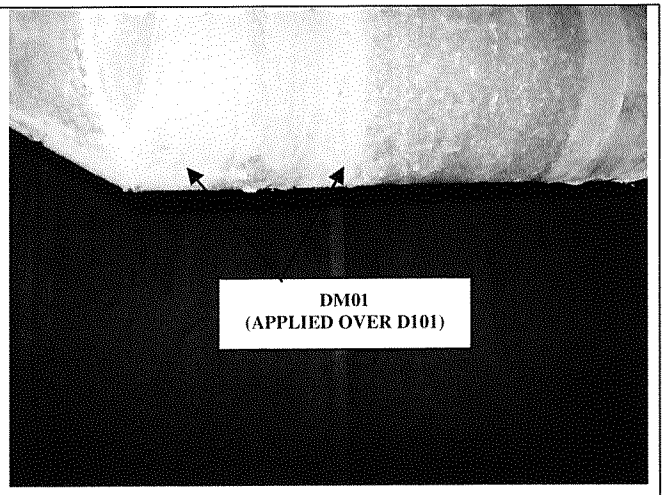
Photo No. 20	
Location: 002

Sample No.: DM01A	
Description: WHITE DUCT MASTIC NON-ACM

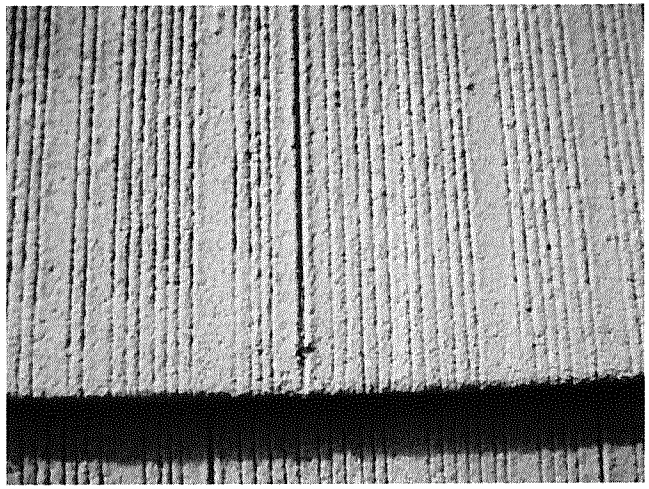
Photo No. 22	
Location: **EXTERIOR**

Sample No.: **AS01A**	
Description: **BLUE ASPHALT SIDING NON-ACM**

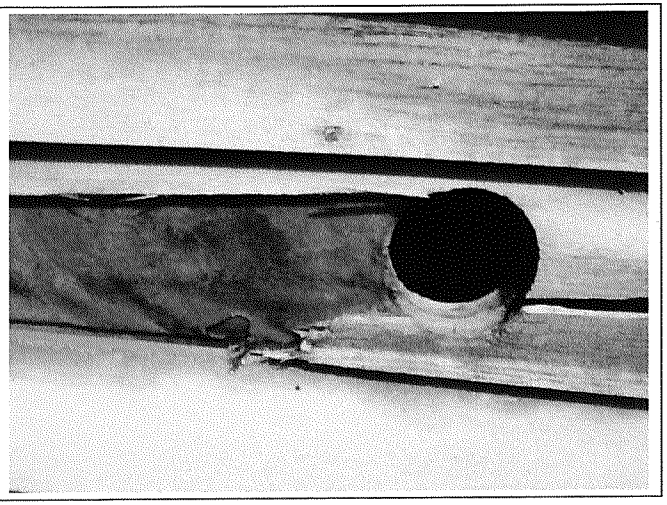
Photo No. 23	
Location: **EXTERIOR**

Sample No.: **VB01A**	
Description: **RED VAPOR BARRIER NON-ACM**

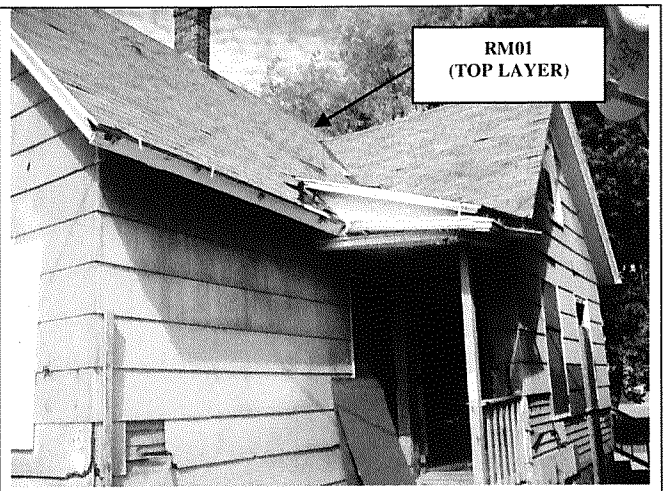
Photo No. 24	
Location: **R100**

Sample No.: **RM01A**	
Description: **GRAY ROOF SHINGLE NON-ACM**

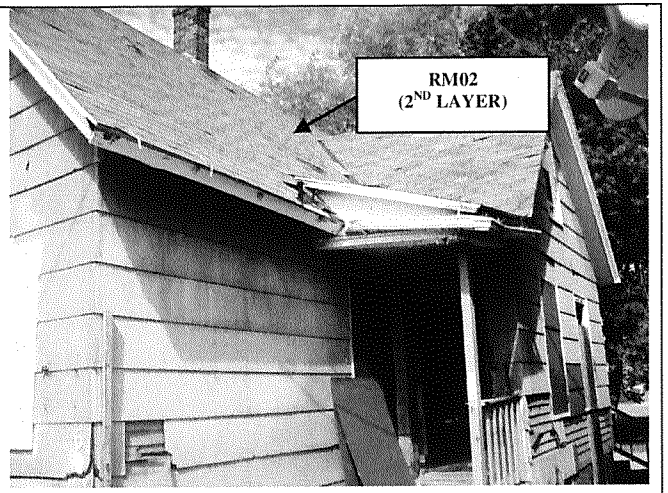
Photo No.	
25

Location: R100	
Sample No.: RM02A	
Description: BLACK ROLLED ROOFING NON-ACM

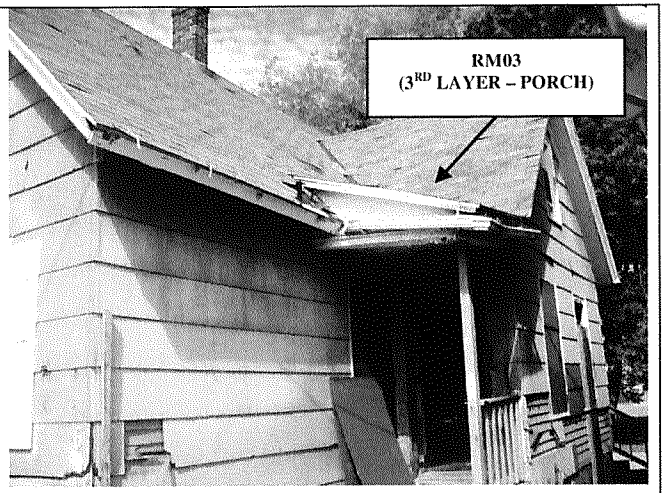
Photo No.	
26

Location: R100	
Sample No.: RM03A	
Description: BLACK TAR PAPER NON-ACM

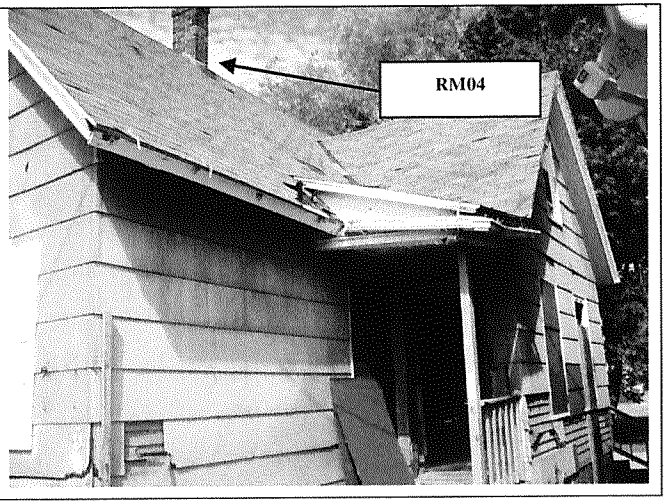
Photo No.	
27

Location: R100	
Sample No.: RM04A	
Description: GRAY ROOF CEMENT NON-ACM
